ELASTIC PITCH BEAM TAIL ROTOR OPERATIONAL  
SUITABILITY INVESTIGATION

Kaman Aerospace Corporation

Army Air Mobility Research and Development  
Laboratory

July 1974

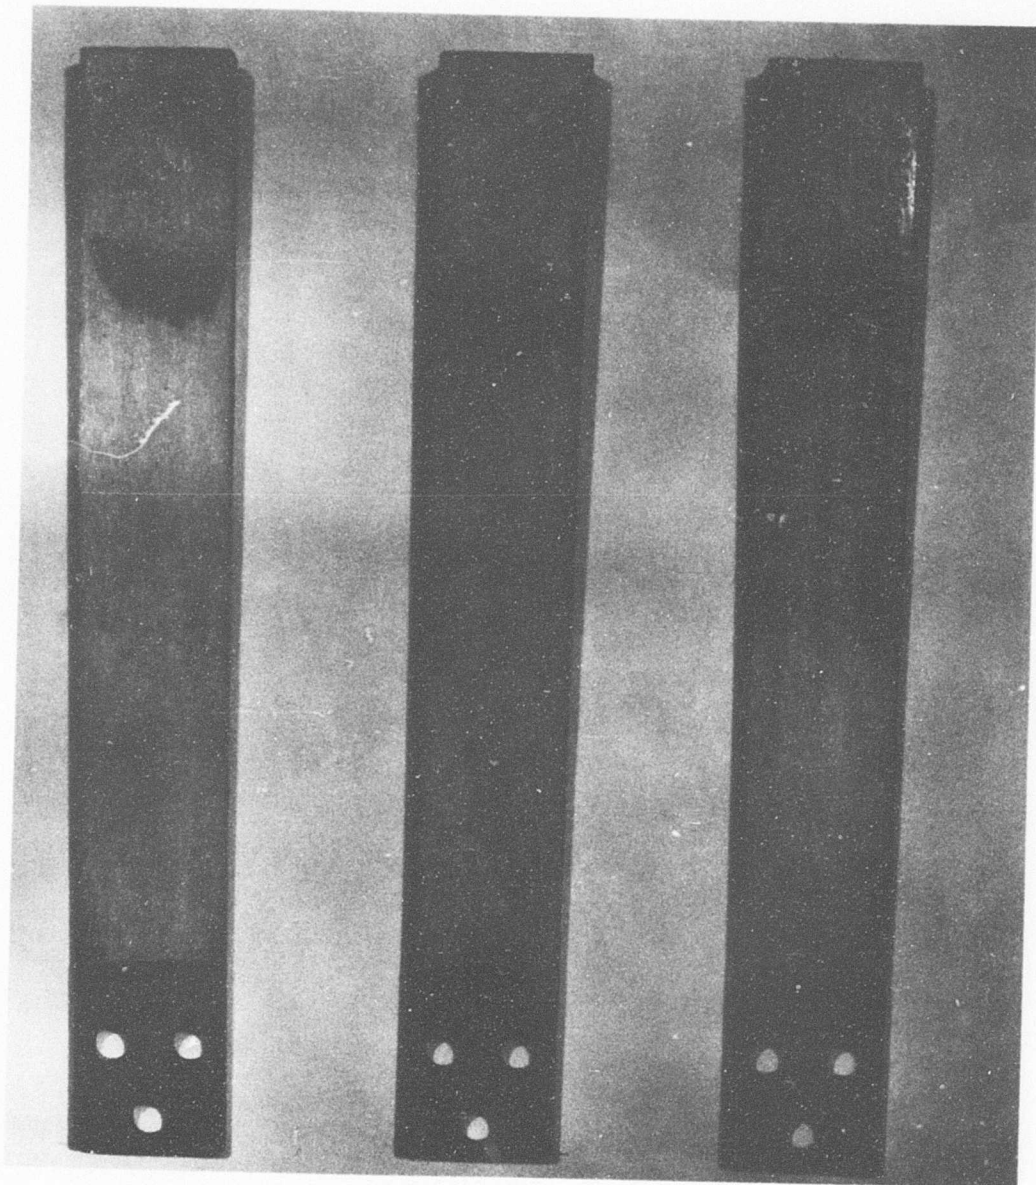
Figure 7. Constant-Deflection Reverse-Bending Fatigue Specimens of Unidirectional S Glass, Type 1002-1014S, Tested at 96,000 psi Maximum Fiber Stress at 200 cpm, No Environment.

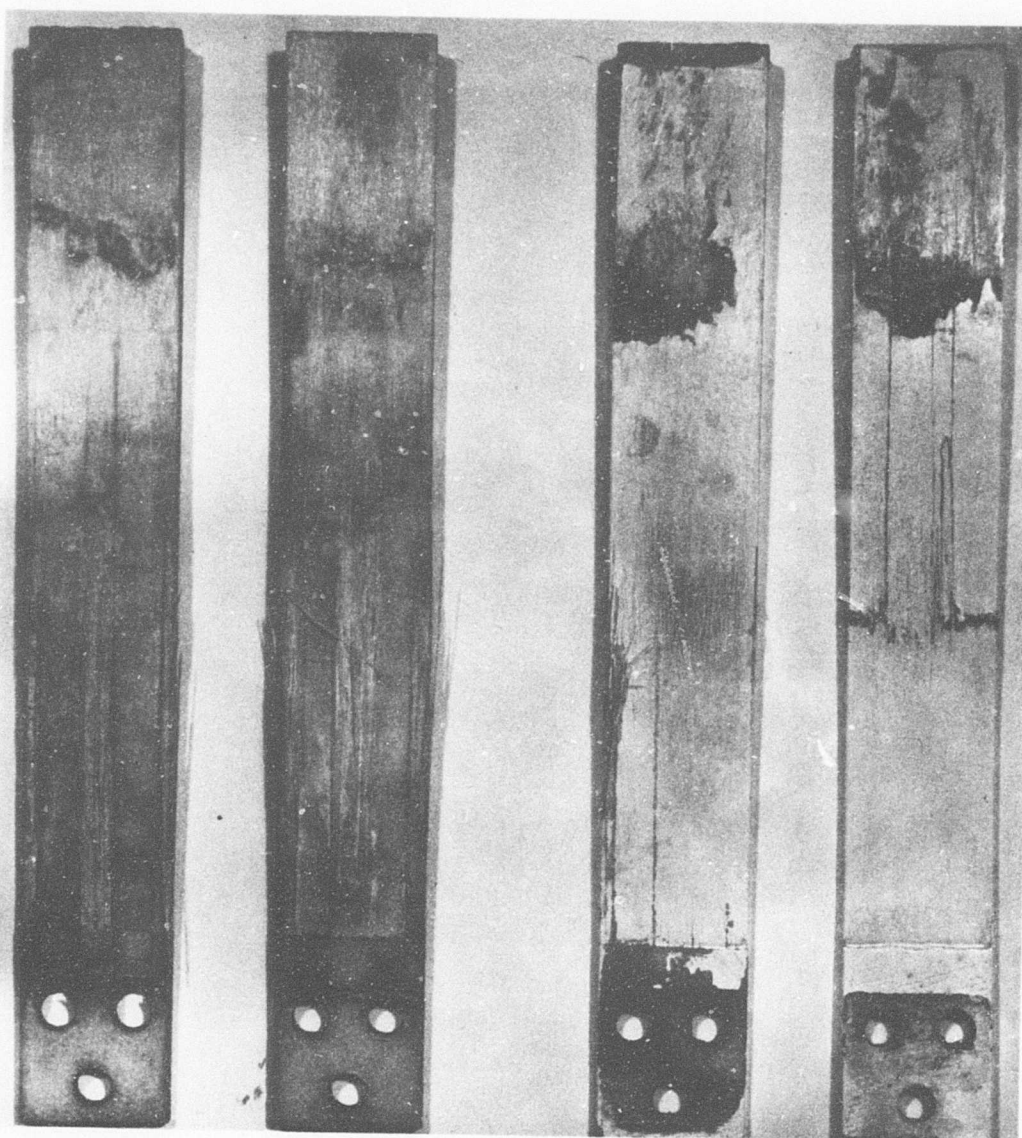
Figure 8. Constant-Deflection Reverse-Bending Fatigue Specimens of Unidirectional S Glass, Type 1002-1014S, Tested at 96,000 psi Maximum Fiber Stress at 200 cpm, Bare and Acrylic Coated Specimens Under Environmental Conditions.

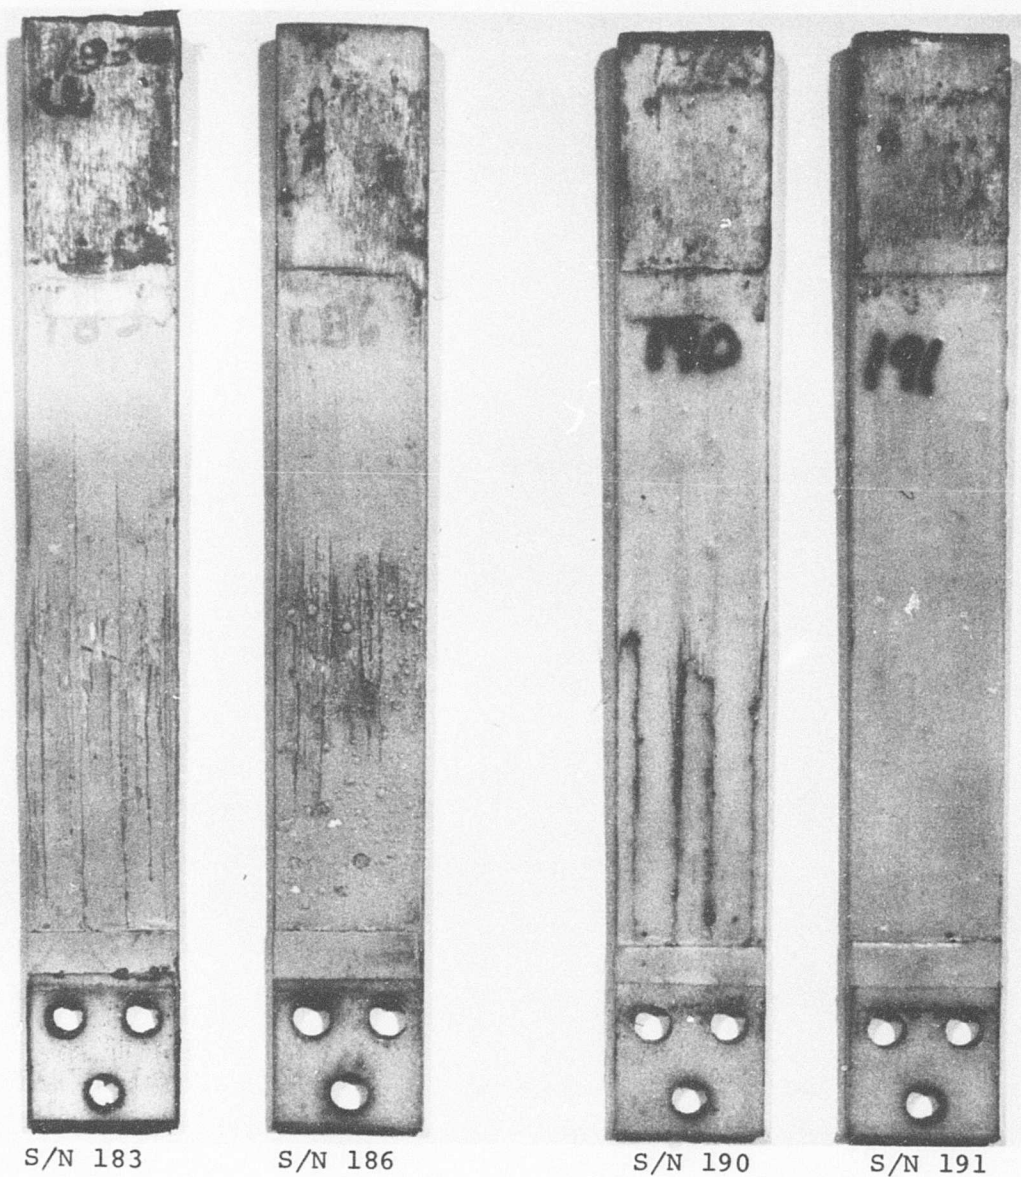
Figure 9. Constant-Deflection Reverse-Bending Fatigue Specimens of Unidirectional S Glass, Type 1002-1014S, Tested at 96,000 psi Maximum Fiber Stress at 200 cpm, Urethane and Adiprene Coated Specimens Under Environmental Conditions.

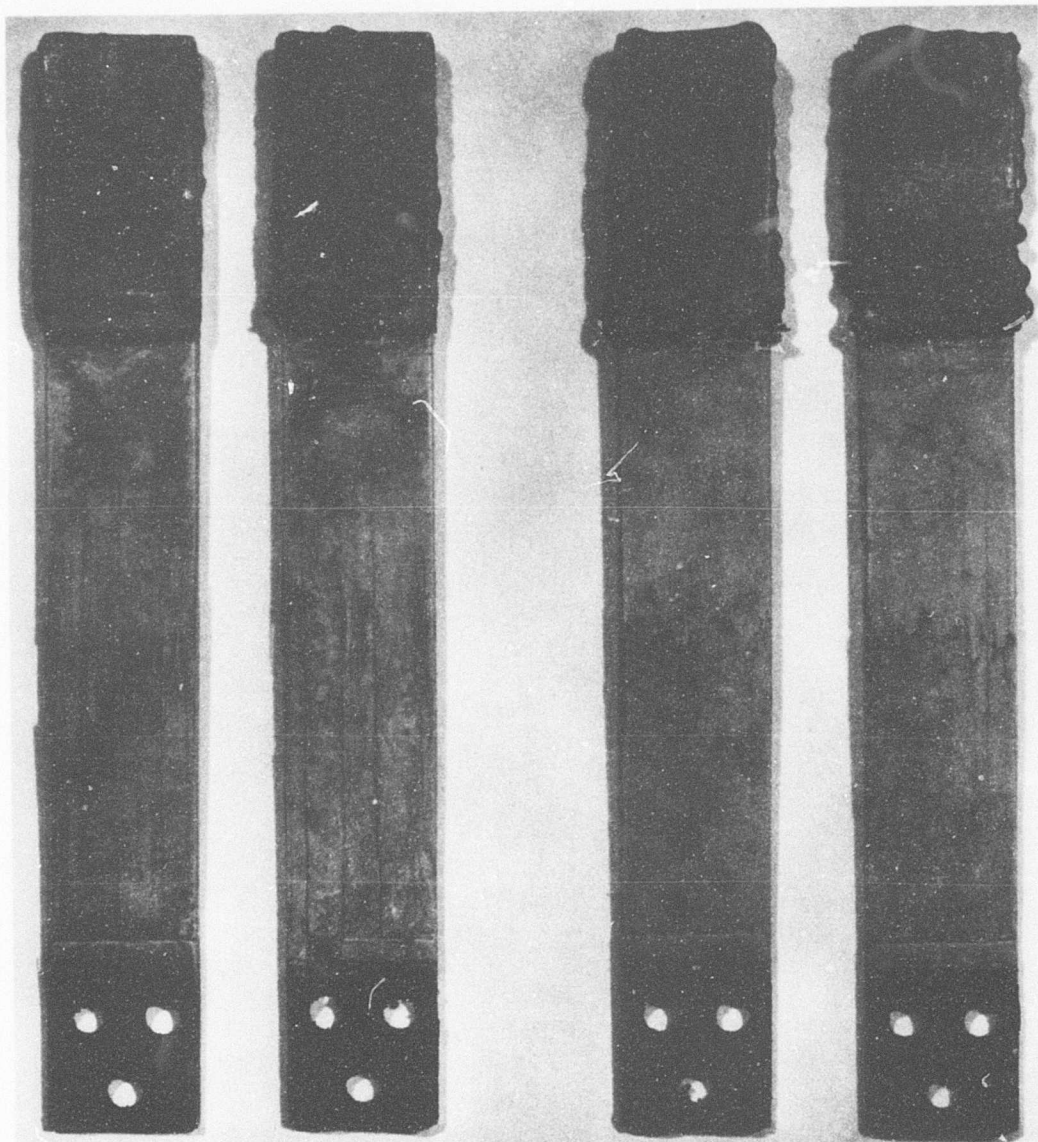
Specimens 202 and 204 were installed without MIL-S-8802 polysulfide sealant at the clamping points, permitting a faster moisture absorption rate and early failures compared to other specimens of the group. Because of this factor, the time for coating failure was considered premature and not graphically presented in Figure 6.

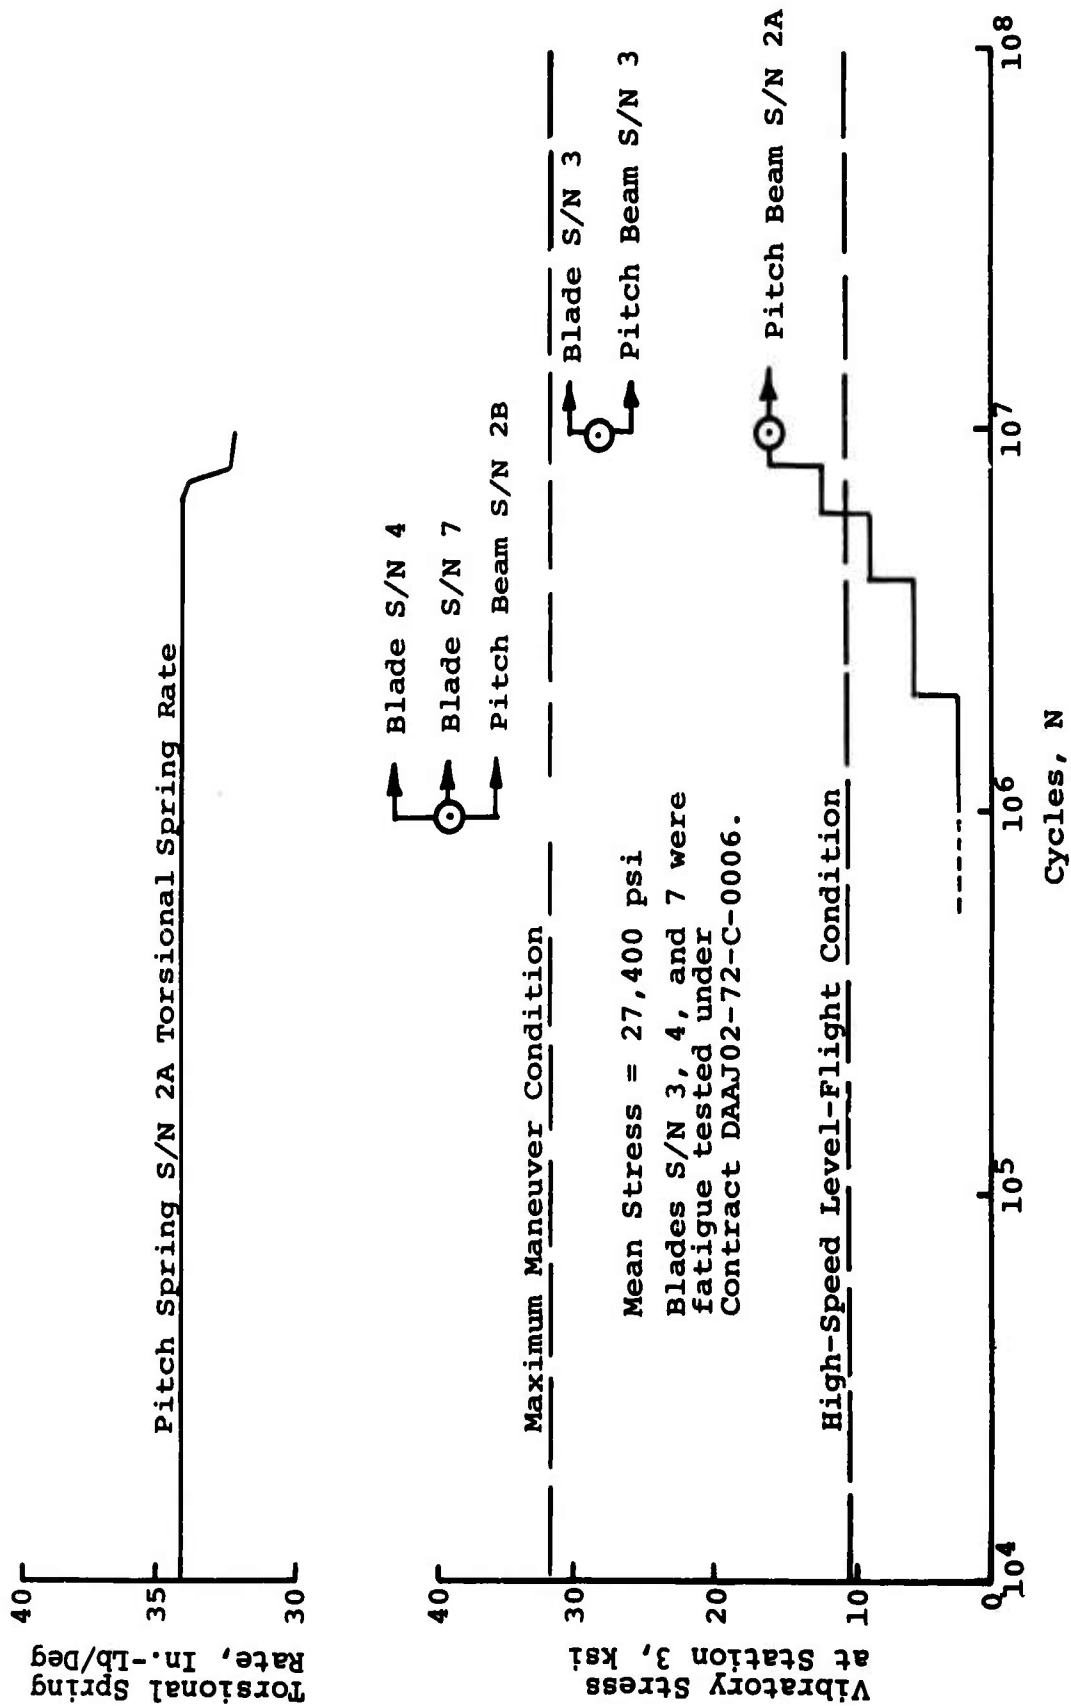
Figure 15. Fatigue Test Results of UH-1 Elastic Pitch Beam Specimens.

Results of the pitch beam fatigue tests shown in Figure 15 provide a preliminary demonstration of the structural capabilities of the UH-1 Elastic Pitch Beam tail rotor design. Load levels imposed on the three elastic pitch beam specimens previously exposed to adverse environmental conditions and protected by Adiprene L-167 coating (S/N 2A, 2B, and 3) were conservatively selected to cover the flight loadings anticipated during high-speed level flight and the majority of maneuvers to obtain a measure of the pitch beam's fatigue performance. The ordinate of Figure 15 is the vibratory stress in the composite spar due to bending loads imposed while the abscissa is the number of cycles of bending stress endured, plotted to a log scale. The steady mean stress due to centrifugal force applied to all specimens was 27,400 psi. In addition to the bending stress cycles plotted in Figure 15, specimens 2B and 3 were subjected to 2000 cycles each of repeated application of centrifugal force (ground-air-ground cycle). The load range was zero to 12,500 lb (0 to 27,400 psi) simulating repeated rotor runups for the purpose of including low cycle fatigue damage effects.

Superimposed at the top of Figure 15 is the torsional spring rate specimen 2A, plotted versus number of stress cycles. Preliminary results had shown some decrease in torsional spring rate for specimens 2B and 3 after test; consequently, specimen 2A was tested to specifically monitor this parameter.

6. As shown in Figure 15, the onset of torsional stiffness degradation of elastic pitch beam specimen 2A occurred at approximately  $7 \times 10^6$  cycles and a vibratory stress level of 4800 psi. At  $10^7$  cycles and vibratory stress level of approximately 6200 psi, a 5 percent reduction in torsional stiffness had occurred. It is conjectured that this loss of torsional stiffness is related to the separation of the interconnecting web and the elastic pitch beam straps.

The separation of the interconnecting webs from the elastic pitch beam strap resulted in a degradation of the elastic pitch beam's torsional stiffness of approximately 5 percent at the load levels tested, as noted in Figure 15 for elastic pitch beam specimen S/N 2A. Similar loss of torsional stiffness for specimens 2B and 3 was evidenced; however, precise measurements were not available. Modest redesign of the strap-web connection could substantially improve the fatigue performance of this joint. An improved elastic pitch beam strap-web connection would also be instrumental in eliminating filament winding failures and fatigue cracking of the aluminum channels by redistributing the stresses in these localized areas.

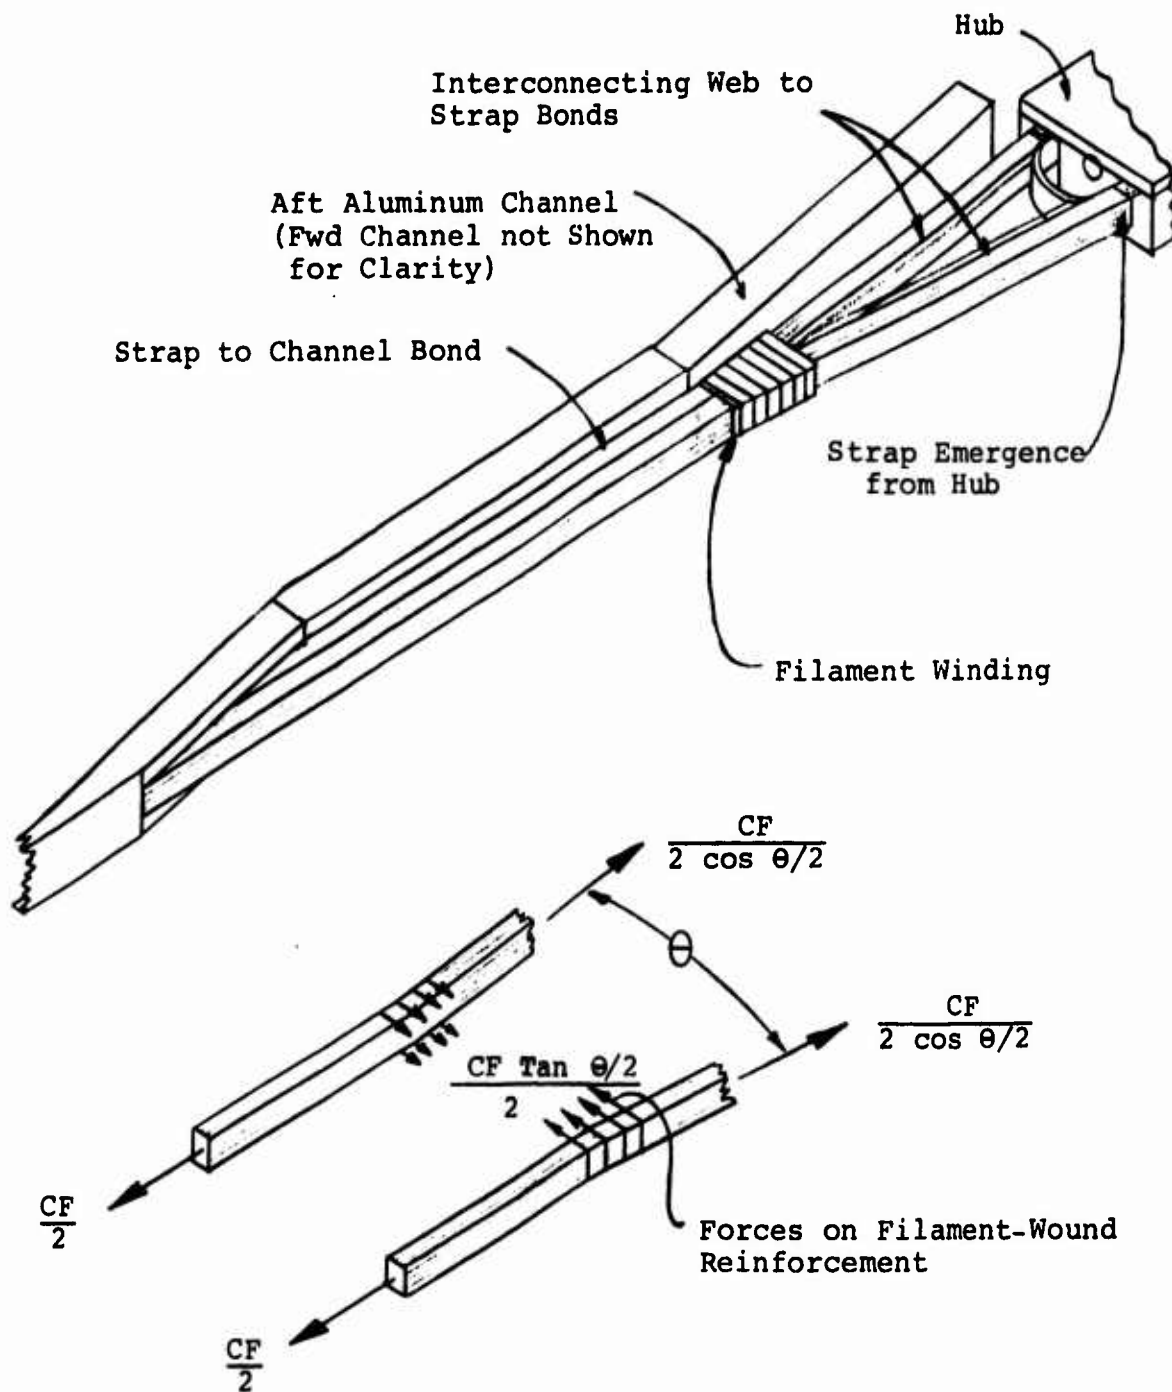
Figure 17. Elastic Pitch Beam Critical Areas.

The critical areas of the unidirectional 1002-1014S glass elastic pitch beam straps that were closely monitored for signs of wear or filament fracture are as illustrated in Figure 17. These critical points are the point of strap emergence from the hub, the interface between the straps and the interconnecting web, the area of the straps directly under the filament winding, and the interface between the straps and the

aluminum channels. The point of strap emergence from the hub is considered to be a prime suspect area for strap failure due to the presence of high vibratory flatwise and edgewise bending stresses, axial stresses due to centrifugal force, torsional shear stresses due to twisting of the straps through the required pitch angles, as well as transverse shear stresses caused by rotor torque and thrust--all of which are conducive to producing high filament stresses, fretting damage at the hub-strap interface, interlaminar shear stresses in the straps, and bond shear stresses between the straps and the elastomer-lined hub interfaces. The straps, along their interfaces with the interconnecting web, are considered to be critical because they are subjected to high shear stresses as well as secondary lateral tensile forces required to maintain the structural continuity between the straps and the web through their bonded juncture, creating interlaminar shear stresses in the outer plies of the strap structure. The area of the straps lying directly beneath the filament winding is also critical because it is subjected to localized lateral shear and bearing forces, tending to cut or fret the filaments of the straps which are in contact with the filament winding. The filament windings are critical themselves because they are subjected to centrifugal induced splitting forces within the laminate caused by a change in strap planform configuration in this localized area. The bonded juncture of the elastic pitch beam strap with the two aluminum channels is also considered to be an area where strap damage might occur. Examination of these critical areas revealed no indication of filament breakage, interlaminar shear failure, or fretting damage associated with the strap design. The conclusion that can be drawn from this evidence is that the strength of the strap and the adequacy of its attachment to the hub and aluminum channels have been clearly demonstrated.

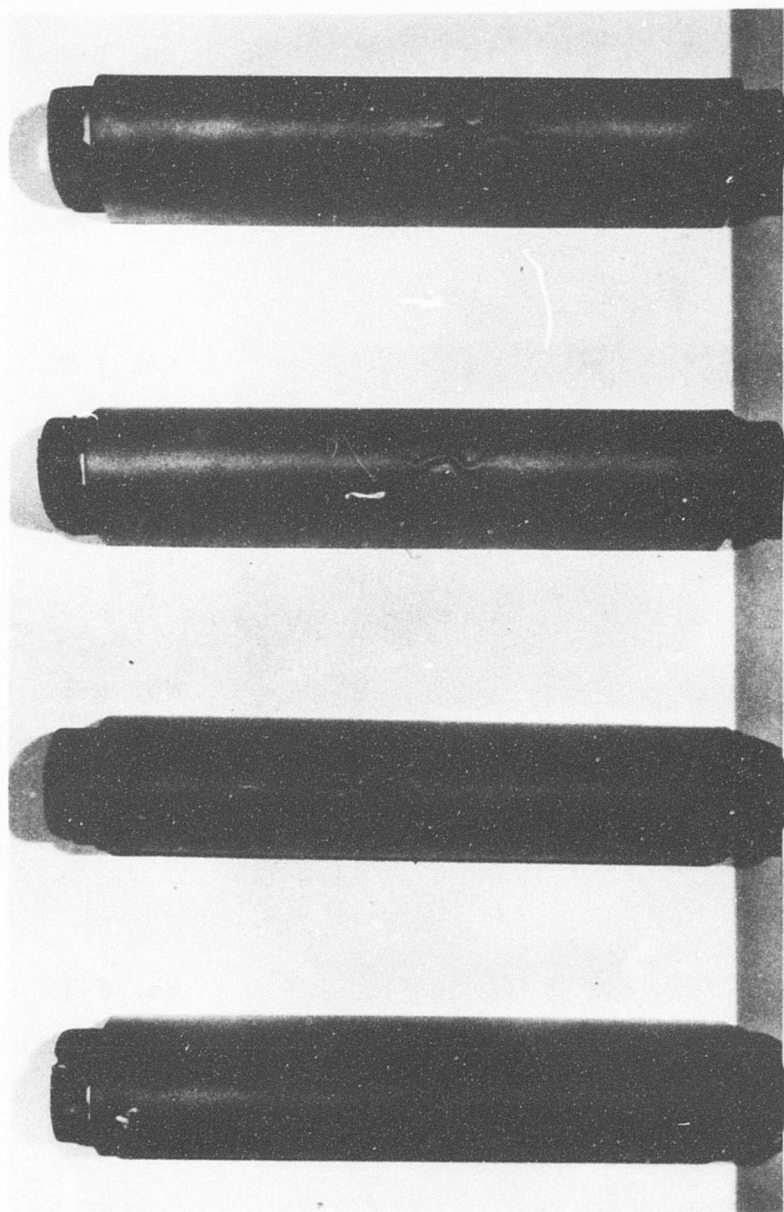
No. 1-4  
.025 Stainless  
35 Min

No. 1-8  
.025 Stainless  
33 Min

No. 2-1  
.032 Stainless  
32 Min

No. 2-4  
.032 Stainless  
39 Min

Figure 29. Stainless Steel Test Specimens After Sand Erosion.

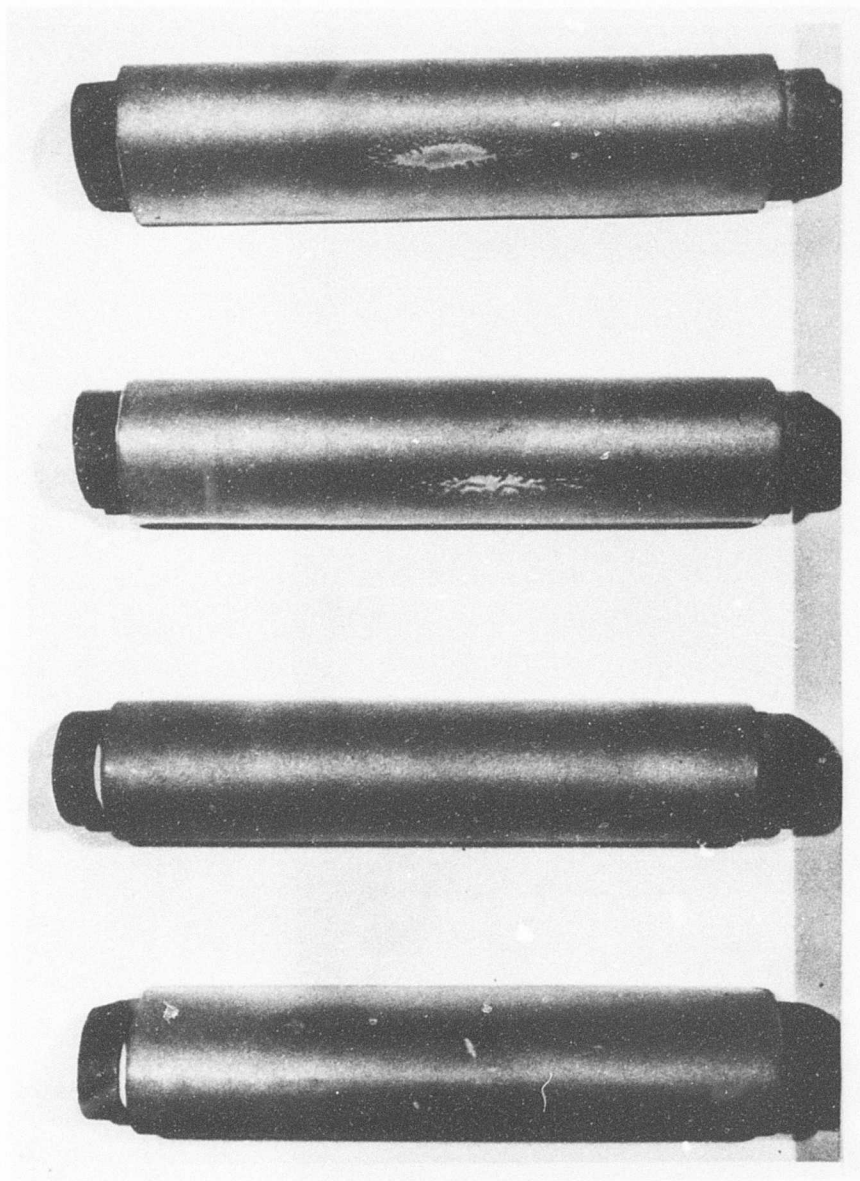
Figure 30. Stellite and Titanium Test Specimens After Sand Erosion.

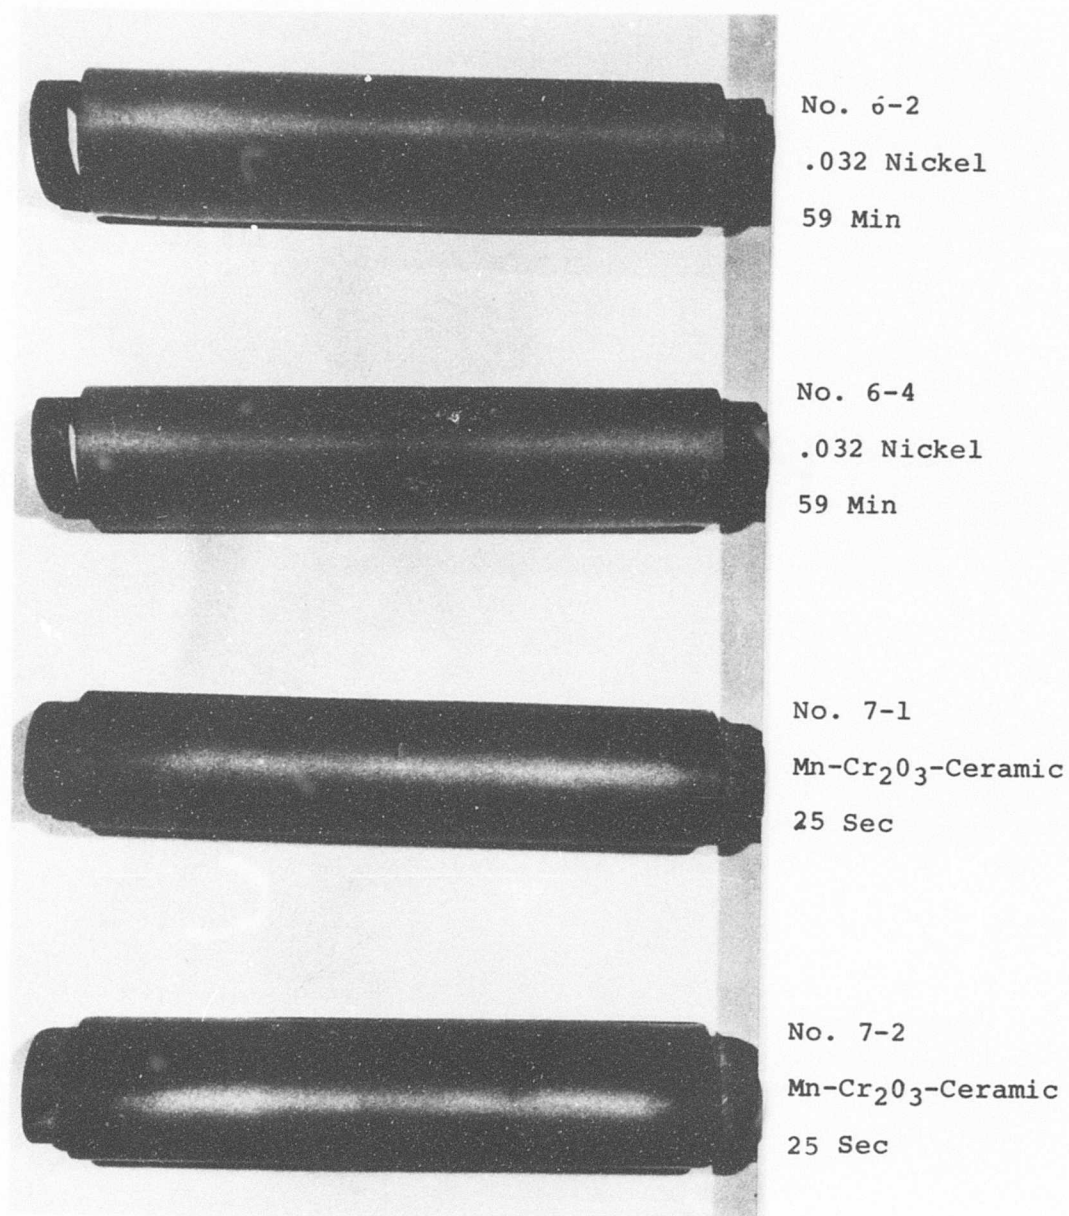
Figure 31. Electroformed Nickel Test Specimens  
After Sand Erosion.

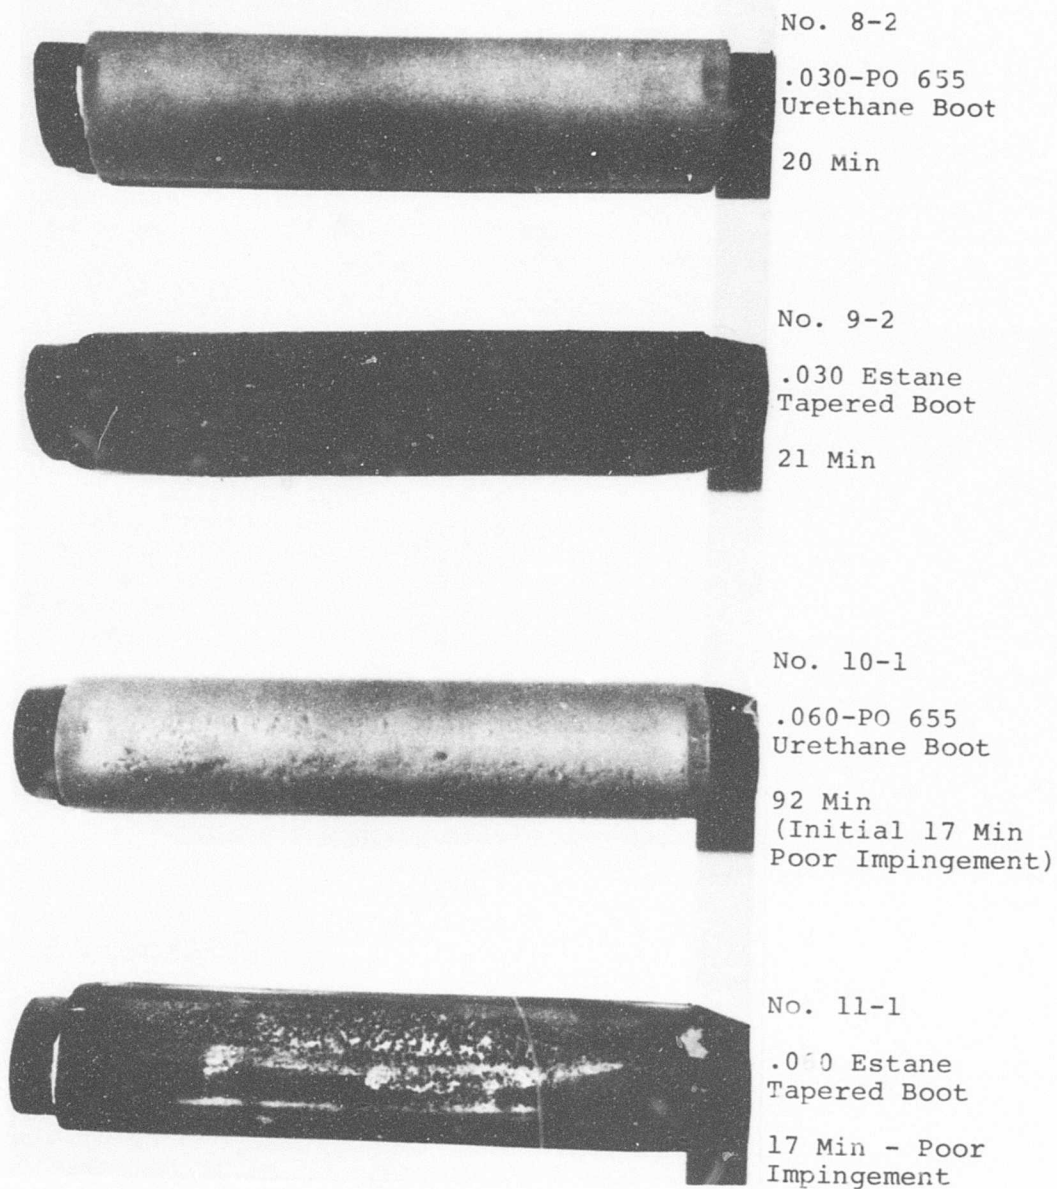
The .030-inch PO 655 urethane boot failed after 20 minutes of test by the development of a small blister or bond-line delamination, 1/8 inch x 1/4 inch in size, which was immediately cut away by the rain. Visually no additional damage was evident.

The condition of the polyurethane specimens after rain testing is shown in Figure 34. Note that specimens 9-2 and 11-1 in Figure 34 were dusted with a talcum powder to reveal the surface texture on the photographic plate.

Figure 34. Urethane-Covered Test Specimens After Rain Erosion.

to any significant rain impingement, appeared to be more severely eroded after 60 minutes in sand compared to its counterpart, specimen 11-2, after 2 hours in sand. This difference in appearance can be seen in Figures 33 and 34. Another factor is the increase in the wear rate on specimen 10-2 during the last 70 minutes of testing. This portion of the testing was performed at a later date and during the same time frame as the half-life testing on the elastomers.

From these observations, it is possible that all the elastomeric specimens subjected to half-life erosion testing were eroded more severely than those previously used to establish sand wear rate, and that the results of rain testing on the specimens may be invalid or conservative.
